# HOME INSPECTION REPORT

**November 1, 2020**

**17631 32nd Ave NE, Marysville**

**REFERENCE #: 1111\_Example**

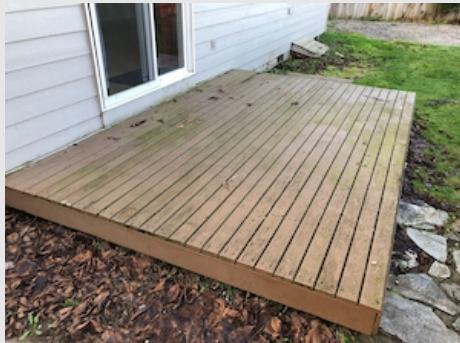
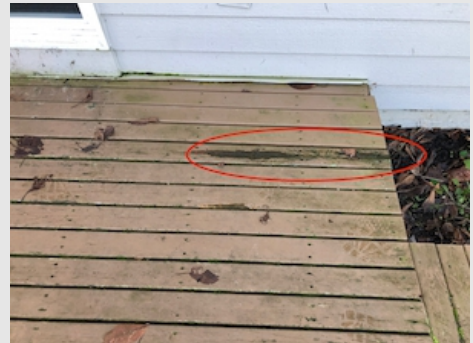
1.41 Type On grade. Structural components were not accessible or visible for inspection due to lack of clearance underneath.  
 1.42 Materials Wood  
 1.43 Steps Earth to wood contact with bottom of stringers and the ground. This will promote decay of untreated wood. It is recommended that direct contact of wood and ground be minimized to prolong the life of the materials. Pull back landscape materials (i.e. bark, sod or dirt) where contacting the posts. Some deterioration observed. Make needed repairs.  
 1.44 Landing or decking Deteriorating materials observed. Make needed repairs and replacement of damaged areas. See WDO diagram for location.

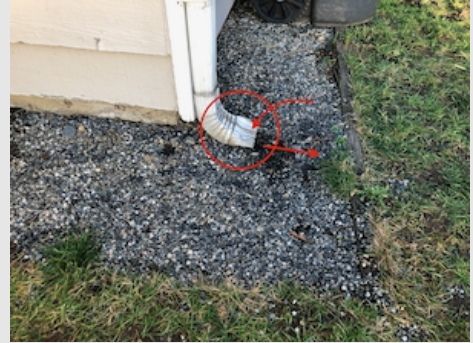
Missing splash block tray and damaged downspout pipe. Splash blocks divert downspout drainage from the foundation of the house. Make needed repairs to splash blocks where missing or improperly installed.

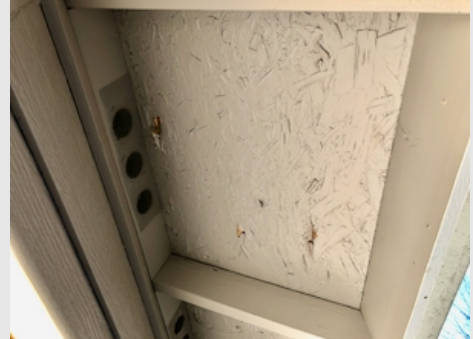
Peeling paint. Remove all loose paint and re-paint all bare wood to protect from moisture.

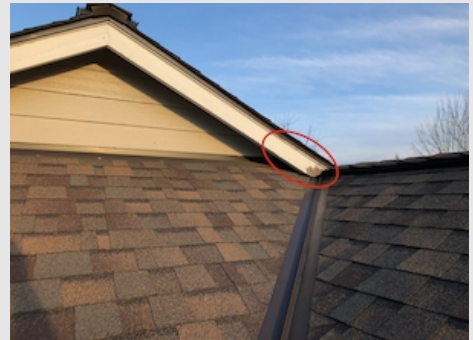
- 2.72 Fascia and rake

Peeling paint. Remove all loose paint and re-paint all bare wood to protect from moisture.

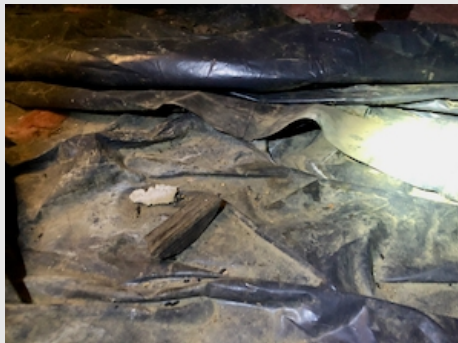
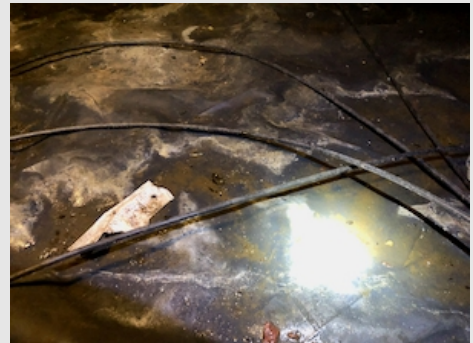
Aging and dirty vapor barrier. This plastic sheeting reduces moisture levels and records future issues in the crawlspace. Remove existing plastic and replace with new vapor barrier.

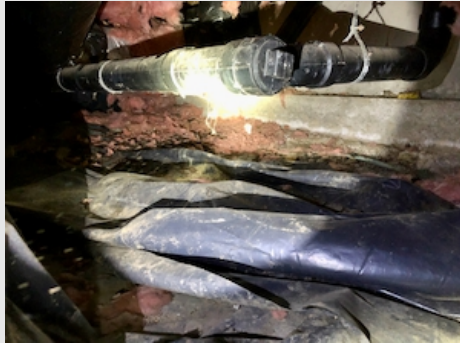
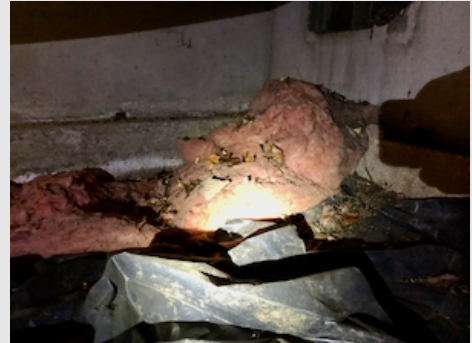
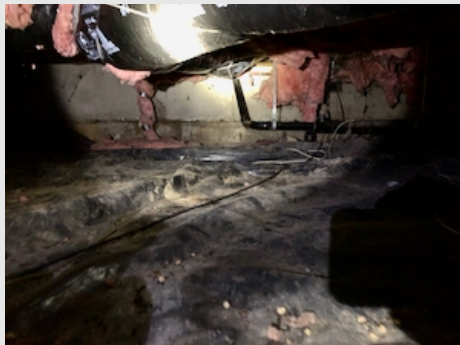
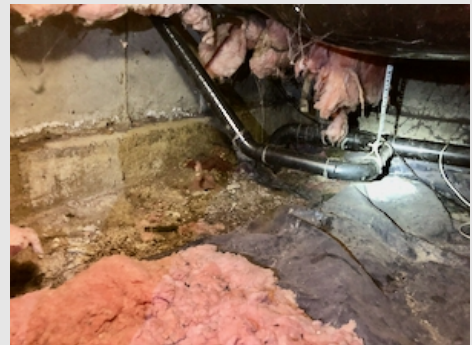
5.14 Ceiling insulation

Falling insulation. This may be due to moisture, improperly installed insulation or rodent activity. Remove all fallen and damaged insulation and make needed repairs to restore insulation to original condition.

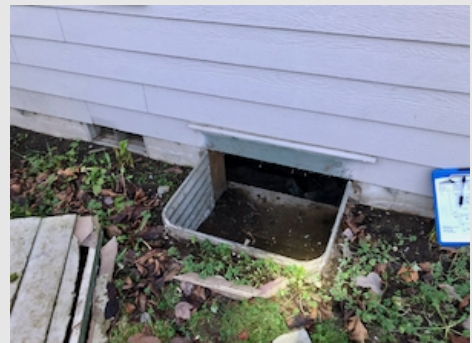
Inadequate crawlspace access cover. Consult contractor for evaluation and repair. Improvements can include an additional screen insert or securely closing cover. Ensure crawlspace access cover protects from both moisture and pest entry in the crawlspace.

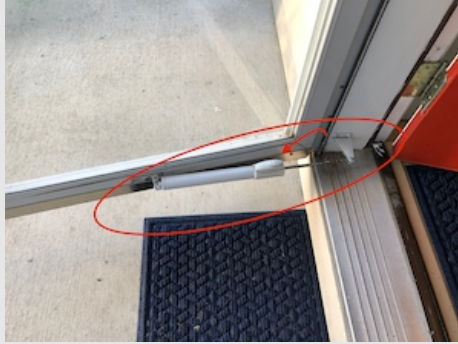
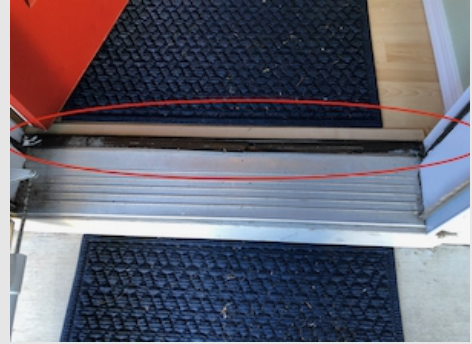
1) Front glass door is not easily opening and closing. Threshold is damaged and making main door difficult to open and close. Make needed repairs to ensure smooth and easy operation of the door.

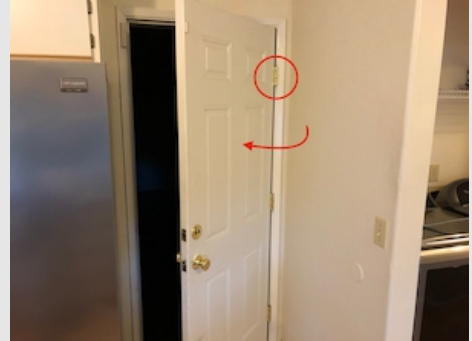
2) Garage door self-closing hinge is not properly operating. This is considered a fire door between the house and garage and the damaged self-closing hinge is a safety concern. Make needed repairs to ensure door properly closes.

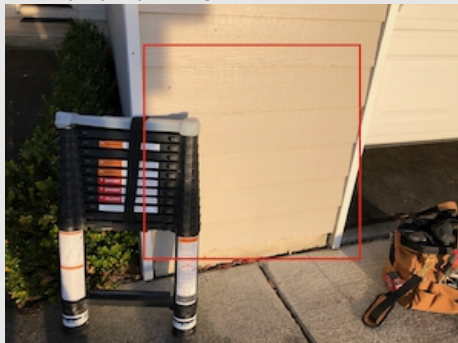
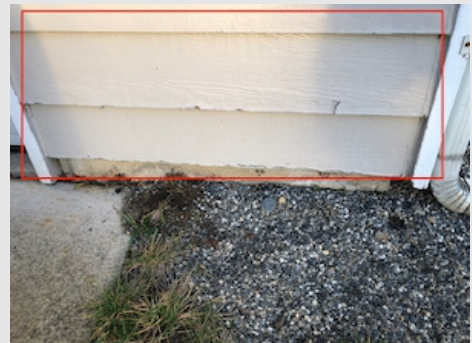
1) LP-type siding issue. Deterioration of beveled siding drip edge on west side. This is a common issue with the wood-fiber siding where it has not been properly painted and sealed. Water beads at this edge and is absorbed into the bottom edge resulting in swelling, flaking and damage. This edge must be carefully cleaned, thoroughly dry and re-painted with a high quality paint to protect from further damage. There are some areas where replacement of the siding is necessary. Consult contractor for evaluation, repair and proper painting.

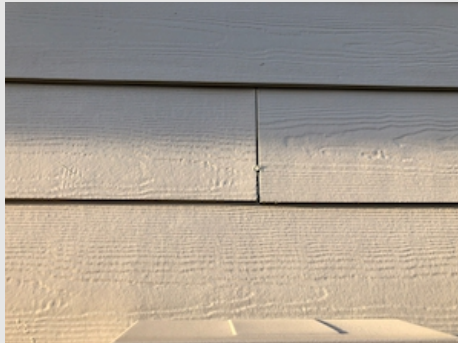
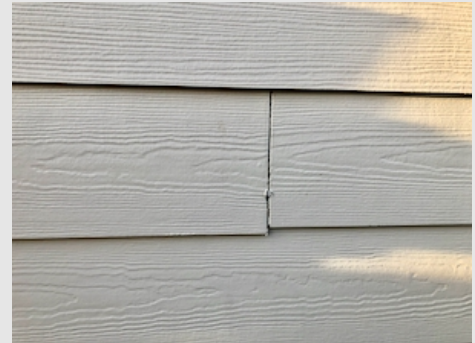
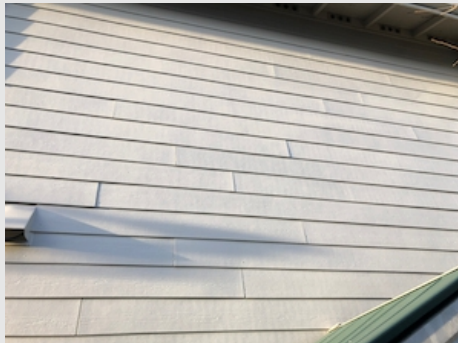
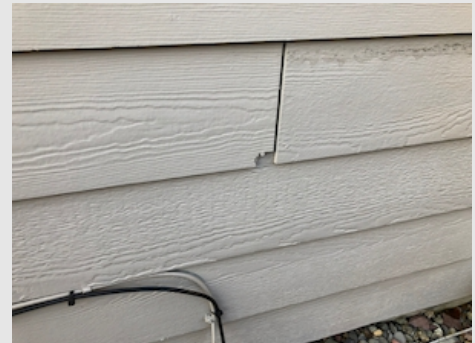
2) Hardiplank siding issue on south side. Installation concerns with the siding planks: 1) Nails have been used to secure the bottom edge and corners of the planks. This is not the proper installation and expansion of these boards will likely result in cracks and broken pieces of the siding. 2) Caulking has been used where joints are to be flashed and not caulked. Consult siding contractor for further evaluation, recommendations and repairs where needed.

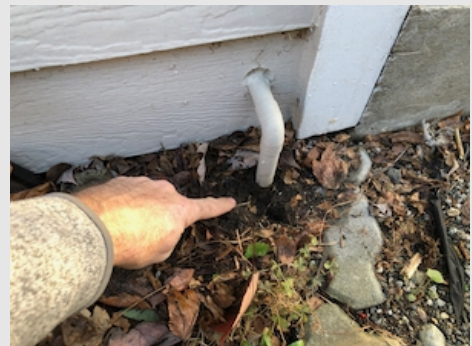
6.36 Other issues

This appears to be the drain pipe for hot water tank PRV extension. Clear end so that this can be monitored for water discharge.

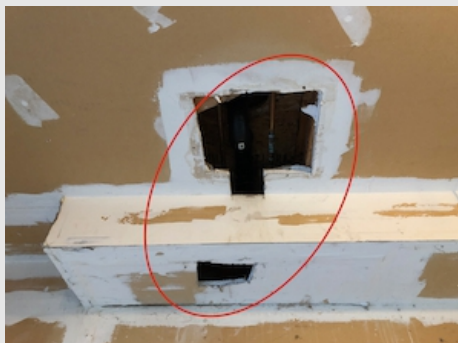
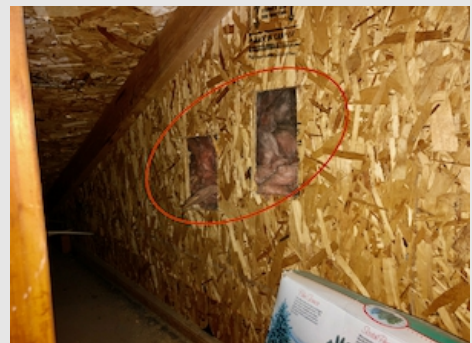
6.43 Condition

Drywall damage: Damaged or missing drywall/OSB between the garage and the house. When fully intact this wall will slow the spread of a fire between the garage and the house. Make needed repairs to restore wall to original condition.

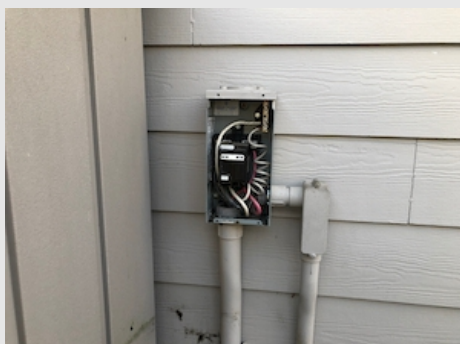
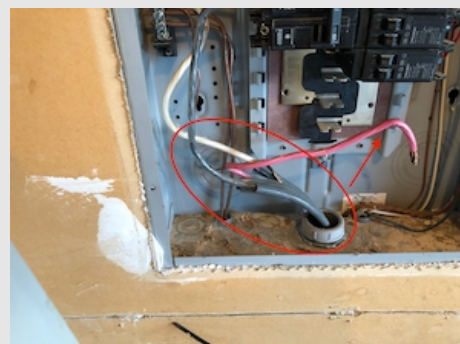
8.21	Location	Garage	
8.22	Panel type	Circuit breakers	
8.23	Panel information	CAPACITY: 200 amp	<i>Single switch disconnect</i>
8.24	Grounding of panel	Grounding rod and wire located. It is located in the ground at the base of the electrical service meter.	
8.25	Panel installation	Improper wiring configuration in panel concerning the spa installation. The 50-amp breaker appears to be energizing the back light fixture. This is a safety concern. Consult electrician for evaluation and repair.

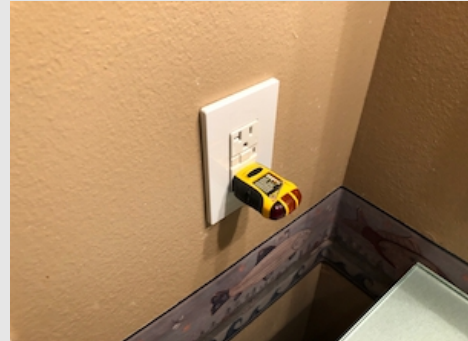
Redundant GFCI receptacle in bath #3. GFCI outlet protection is provided for this outlet and this device is not needed in this location. A repair is not required but resetting this receptacle will first require a resetting of the primary GFCI switch. Consult electrician for further evaluation and repair.

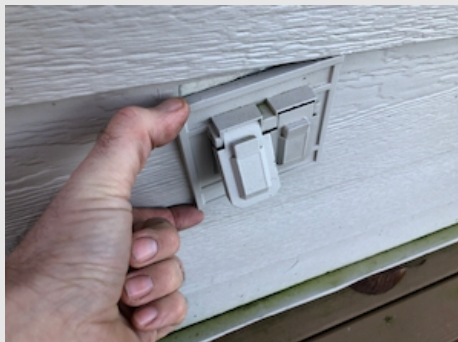
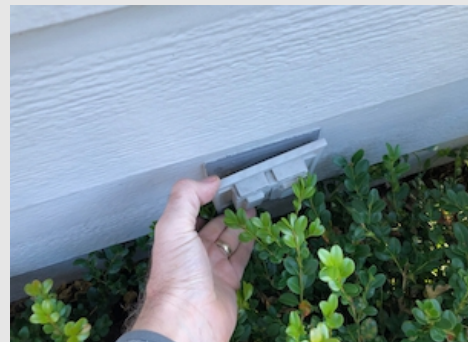
1) Loose weather covers with exterior outlets. Make repairs to protect receptacle from moisture.

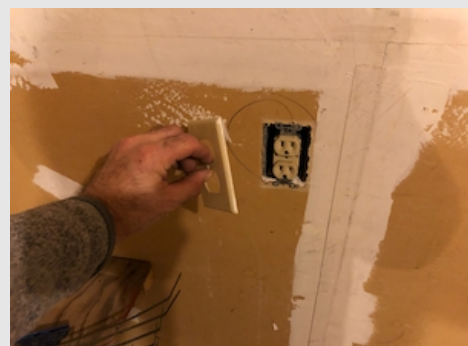
2) Missing receptacle cover screw in garage. This is a safety concern. Ensure all outlet receptacles have a properly secured cover in place.

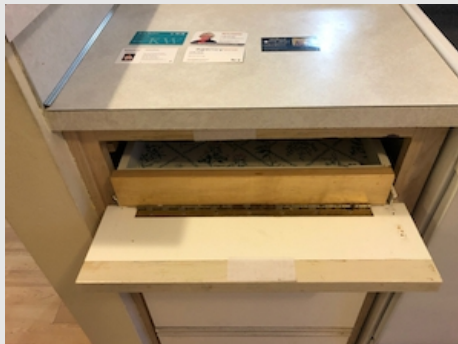
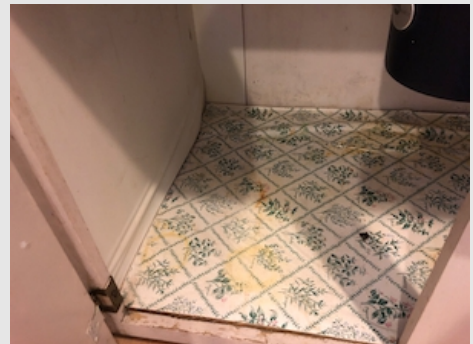
Wear and damage observed. Repairs will be needed to ensure doors/drawers/finishes are returned to original working condition. Consult contractor for evaluation and repair.

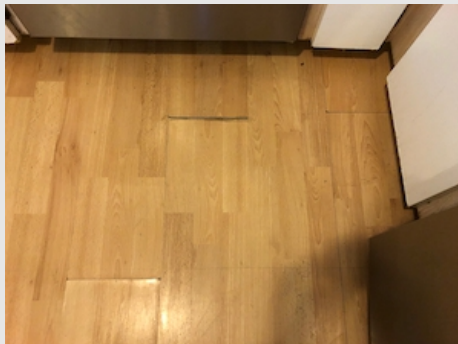
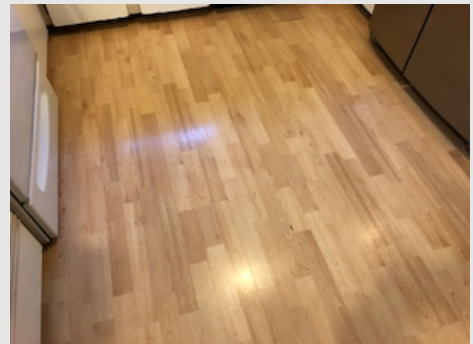
Laminate. Significant signs of wear and some moisture damage. Make need repairs or replacement.

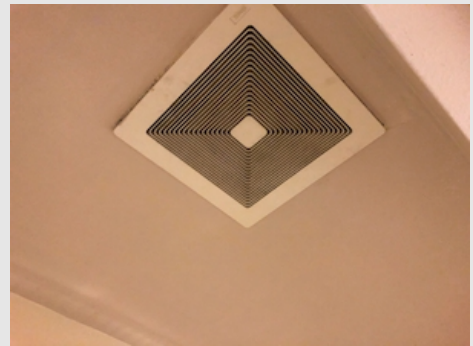
Not operating. Make needed repairs. Whole house fan timer is present. Operate this fan for 2-4 hours daily to help ventilation of moisture and circulation of household air.

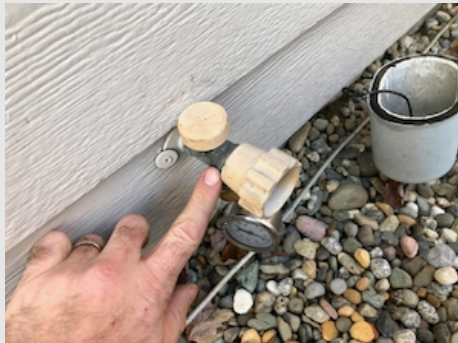
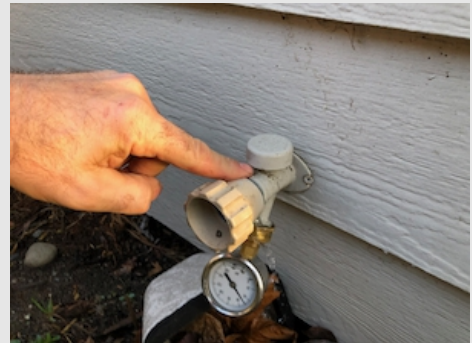
Frost free faucets. Issue: Minor leak noted at faucet handle when in use. Consult plumber for evaluation and repair to reduce water loss when faucet is in use. Disconnect hoses and devices to protect from freezing temperatures.

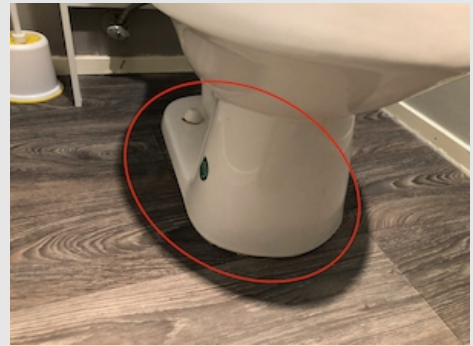
Loose toilet. This can result in leaking at the wax ring below. Consult plumber for evaluation and repair.

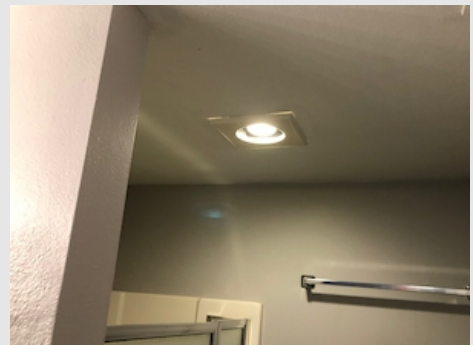
Excessive noise observed with fan. Consult contractor for evaluation and repair or replacement.

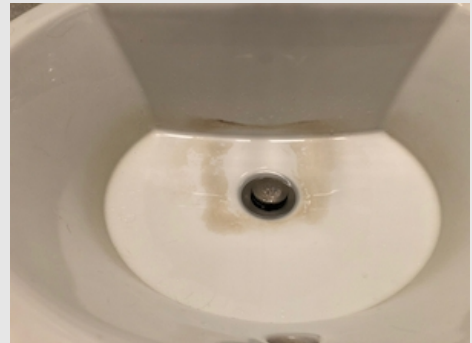
No issues observed  
No issues observed  
No issues observed  
Staining in sink finish. Make needed repairs.

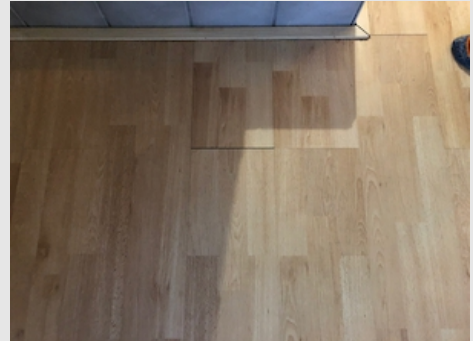
Excessive use and wear with laminate. Consult flooring contractor for evaluation and repair or replacement of worn flooring.

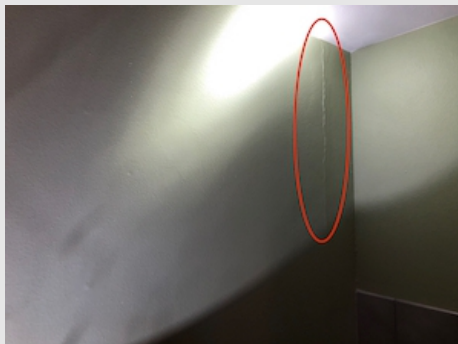
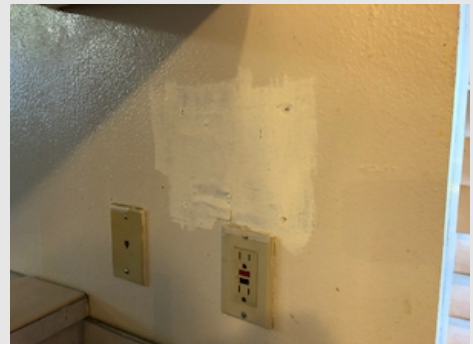
Minor use and wear. There are some areas where clean up, touch up paint, or other minor repairs will be needed to return the wall board to original condition.

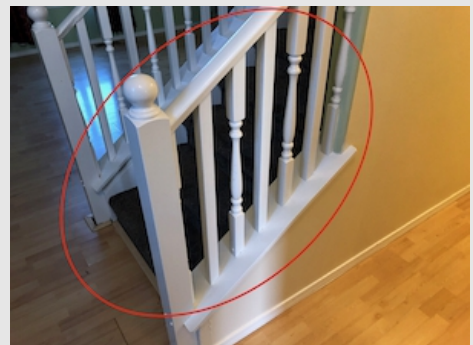
Loose handrail. Consult contractor for evaluation and repair.

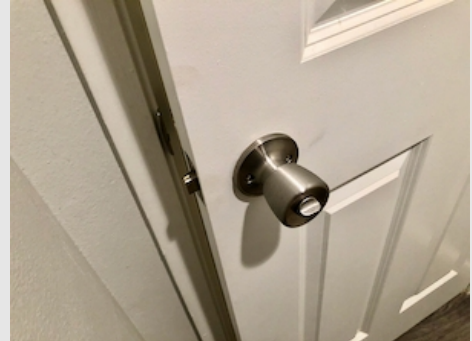
Issue with door latch that is not engaging properly. Make necessary adjustment or replace door handle and latching mechanism if these are faulty.

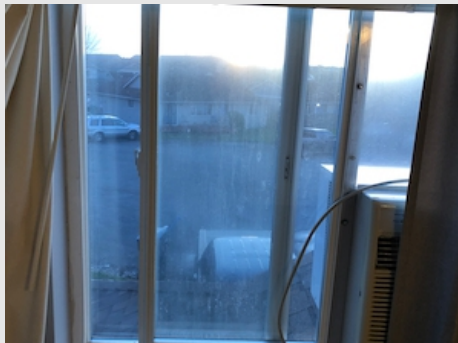
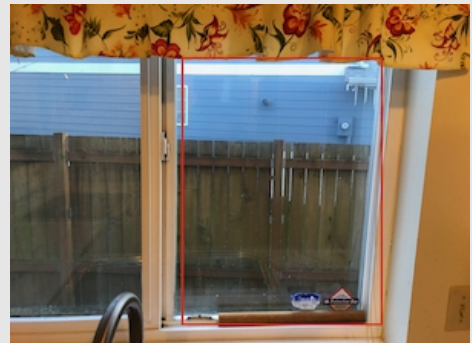
1) Lost vacuum seal with double pane insulated window(s). This will result in condensation, fogging and a film that cannot be removed from between the panes. While not a structural concern, it will be an ongoing aesthetic issues. Consult window contractor for evaluation and repair.
