INSPECTION DATE

December 2, 2020

PROPERTY INSPECTED

555 Filbert Rd, Lynnwood, WA 98036

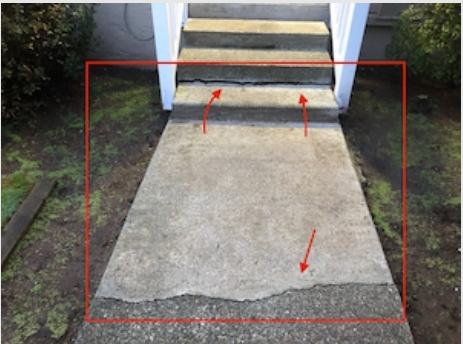
<p>1.10 GRADING</p> <p>1.11 Next to home</p> <p>1.12 Overall yard</p>	<p>SATISFACTORY</p> <p>No issues observed</p> <p>No issues observed</p>
<p>1.20 GROUNDS</p> <p>1.21 Walkway</p>	<p>REPAIR NEEDED</p> <p>Some cracking noted in surface. This can be a common issue caused by curing or settling. It is recommended that cracks be sealed to protect the from moisture penetration and repairs be monitored for further erosion or displacement.</p>

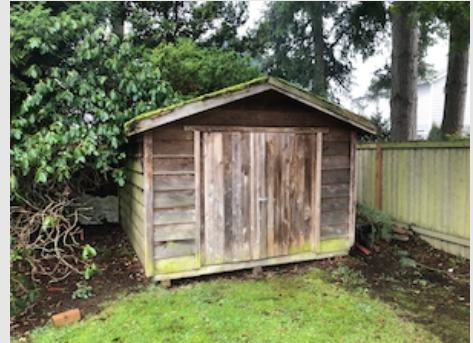
1) Shed present. There are areas of minor deterioration and structural concerns. Repairs will be needed to make the shed fully functional.

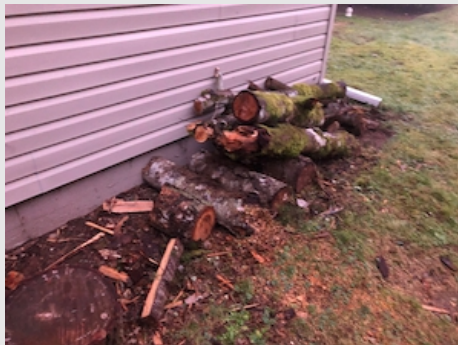
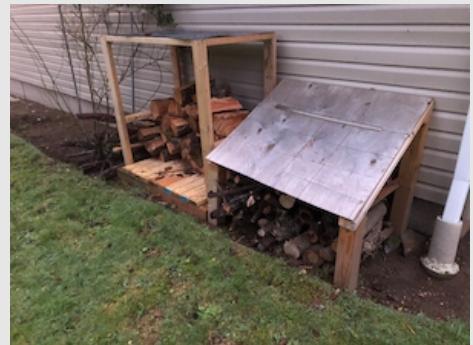
2) Conducive debris. Scrap wood, firewood, and/or other wood materials against the house is a wood-destroying organism (WDO) conducive condition. Move these items away from the house and monitor these areas for pest activity.

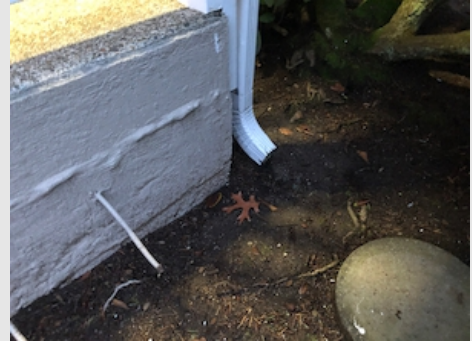
1.34 Landing

No issues observed. **Issue:** Some rebar sticking out at side of landing. This could be a safety concern. Remove hazards or use caution when accessing this area.

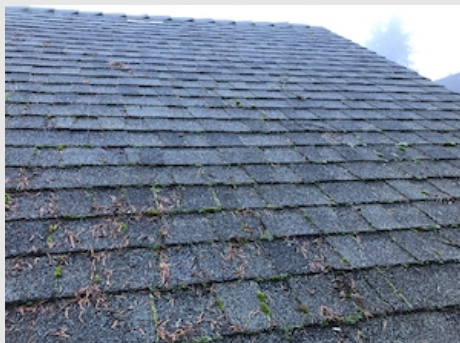
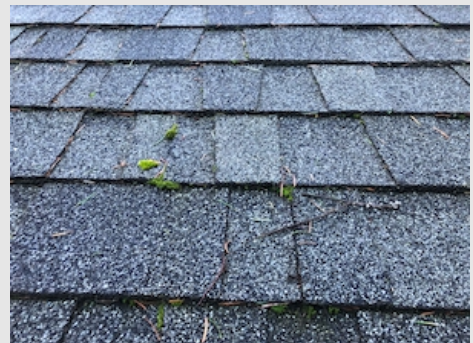
1) Organic debris from trees present on roof. Clean all debris from shingles, debris, and gutters to prolong the life of the roof and reduce obstructions in the drainage system. Use non-abrasive treatment process. 2) Moss present on roof. Clean organic growth from all roofing shingles to prolong the life of the roof. Ensure contractor uses a non-abrasive treatment process (no brooms or pressure washers).

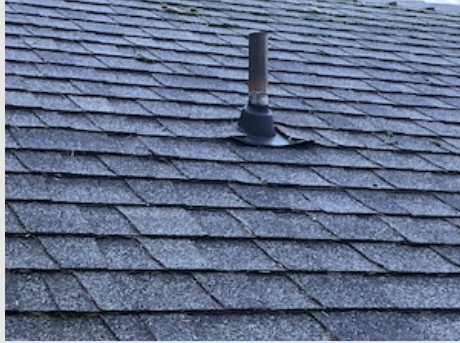
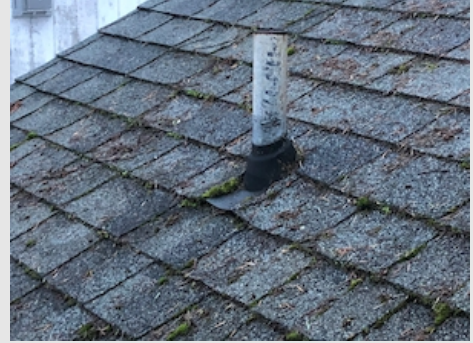
Plumbing vent boots aging. Boots are beginning to lift and crack around the edges. This can permit water to potentially enter at sides of vent pipes and into areas below. These boots have a typical life expectancy of 15-20 years. It is recommended that a roofing contractor evaluate and replace the deteriorating boots.

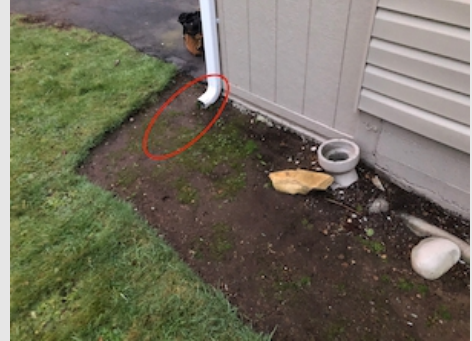
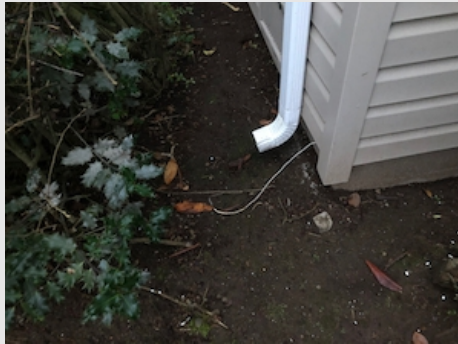
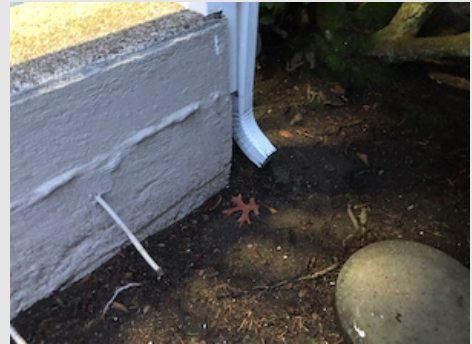
1) Drains present. Issue: Debris visible in drains. Obstructed drains can result in water pooling near the house. Make needed repairs to clear drains and ensure proper water drainage. 2) Missing splash block trays. Install trays to ensure water moves away from the foundation of the house.

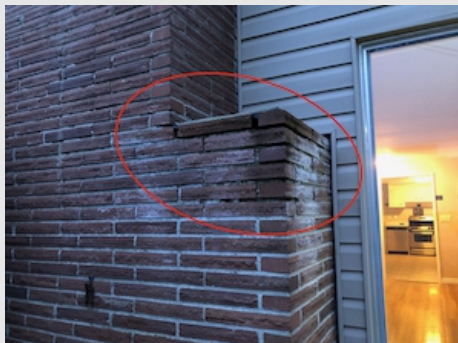
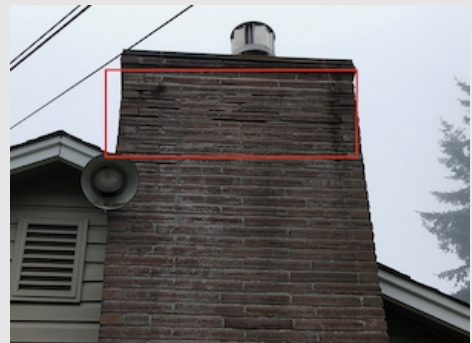
Deteriorating mortar. Mortar is loose and missing which can result in loose bricks and moisture entry. Consult chimney specialist or mason for evaluation and repair.

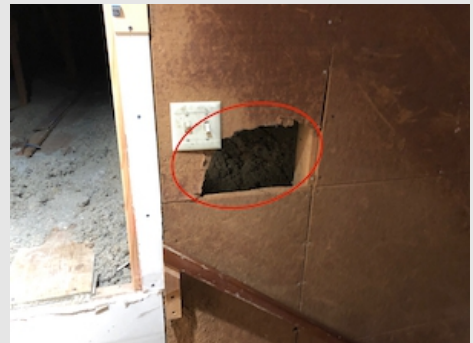
3.12 Attic access

Scuttle hole cover. Some damage to attic wall by stairs. Make repairs to seal this area.

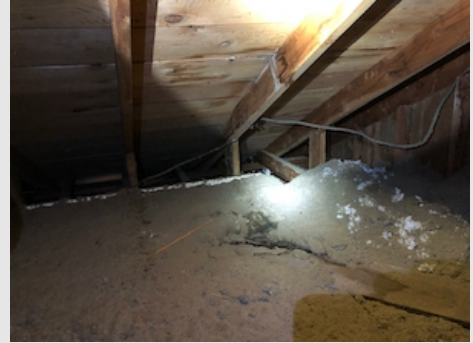
Evidence of a roof leak. It could not be confirmed if this was a past issue or a current issue. No staining visible in the ceiling below. Re-inspect the roofing in this area, clean the area in the attic, and monitor for further issues.

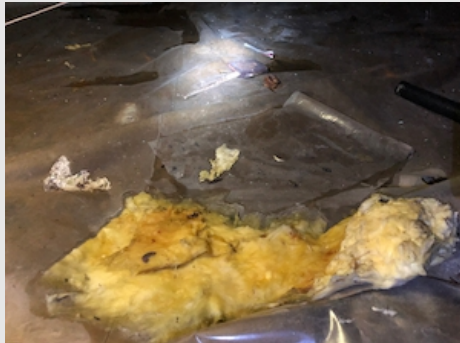
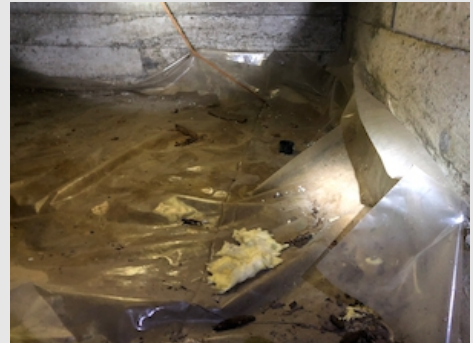
Dirt
Aging and dirty vapor barrier. This plastic sheeting reduces moisture levels and records future issues in the crawlspace. Remove existing plastic and replace with new vapor barrier.

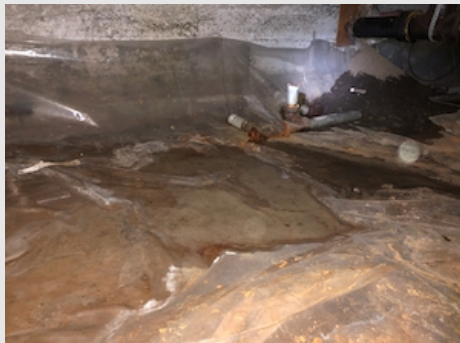
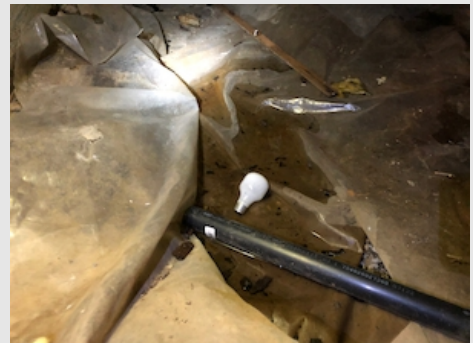
No issues observed
Not applicable
No issues observed. Supply pipes were not visible as they were properly insulated. Waste lines appear to be in good working order.
1) Standing water present in the crawlspace. This appears to be related to grounds drainage. Furthermore, this is a conducive condition for wood-destroying organisms and organic growth due to excess moisture levels. Make needed modifications and repairs to ensure water does not pool in crawlspace.

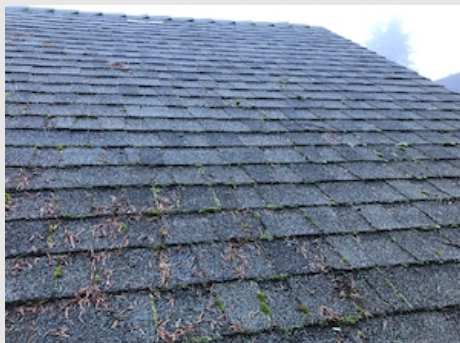
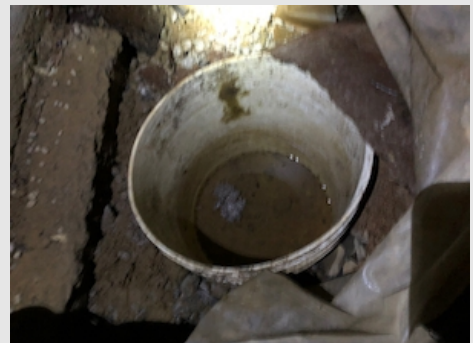
2) There is a bucket with perforations present. This appears related to drainage or possibly a past sump. Consult contractor for further evaluation and recommendations.

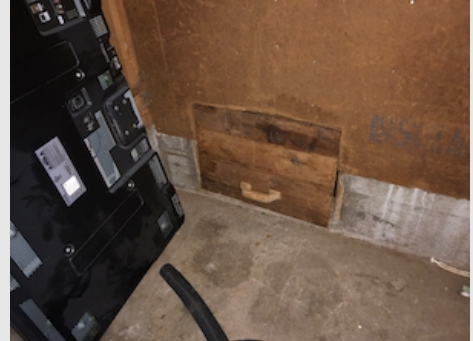
Inadequate crawlspace access cover. Ensure crawlspace access cover protects pest entry in the crawlspace and can be secured in place.

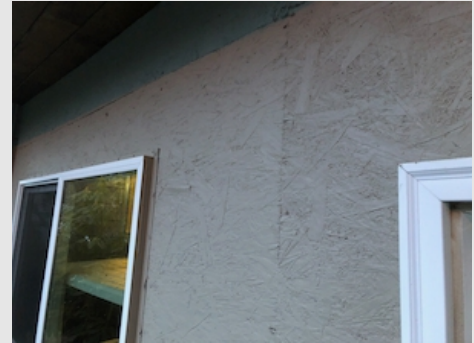
6.32 Condition

Carport conversion is inadequate. OSB is not a proper material for exterior application and the window is not properly flashed. Consult contractor for evaluation and repair.

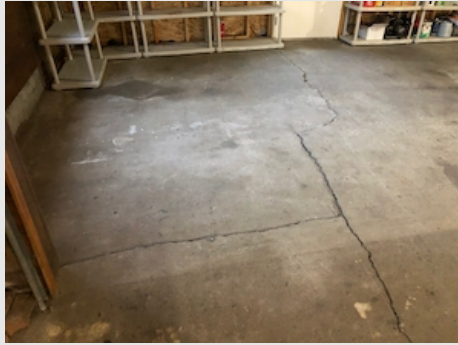
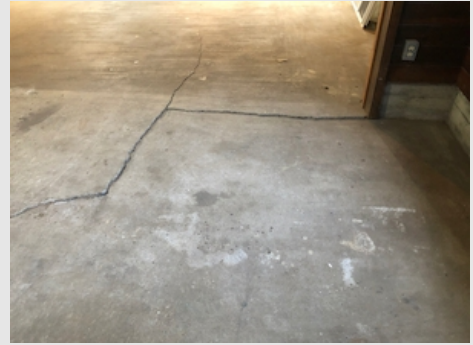
Confirm operation of automatic opener. The floor sensors were not properly installed at the base of the overhead door. Make needed repairs.

Floor cracks: Some cracking is present with slab floor. This does not appear to be active. It is recommended that all cracks be sealed and continue to monitor for further displacement.

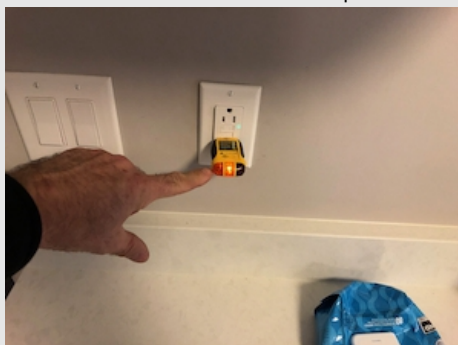
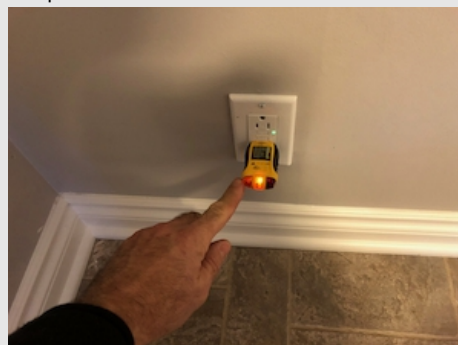
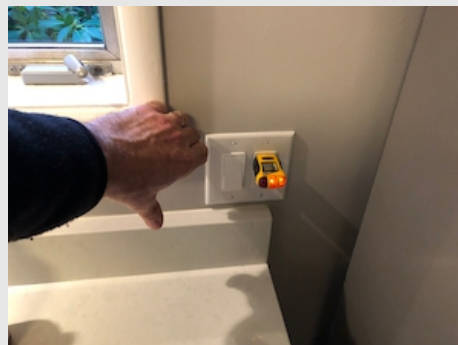
Not operating properly. The testing device or the test switches on the receptacle did not trip as designed. Consult electrician for evaluation and repair of GFCI outlet protection.

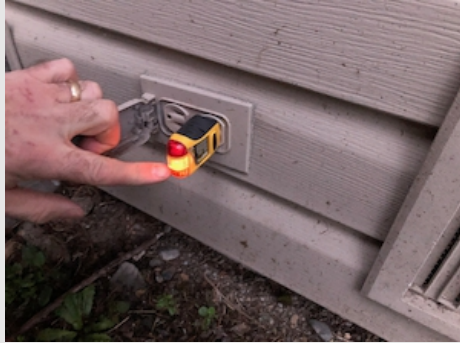
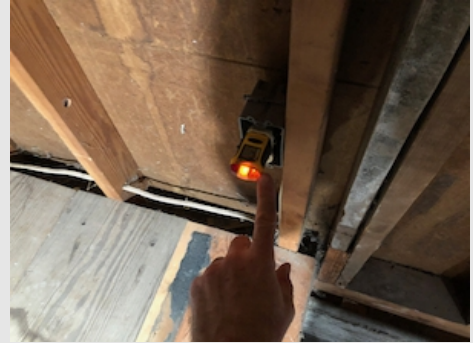
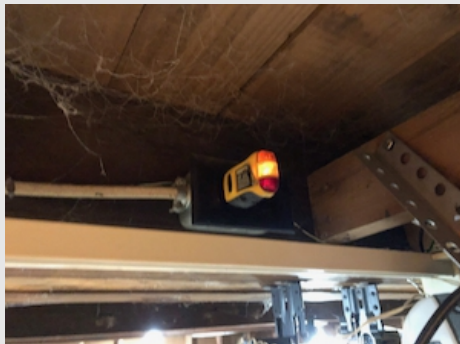
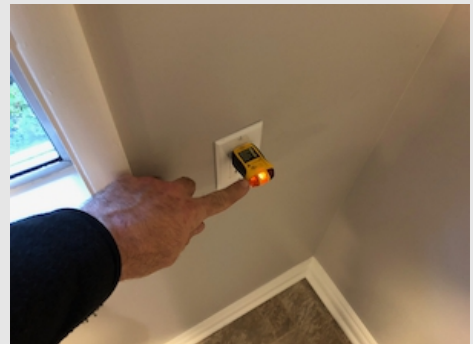
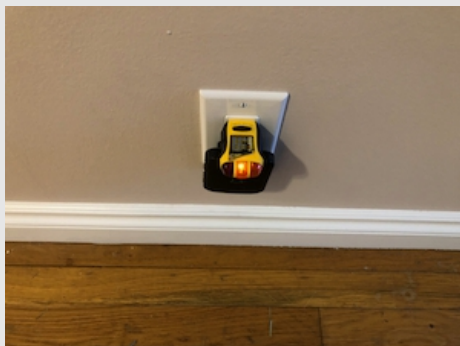
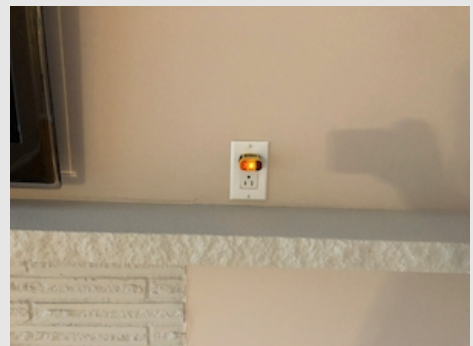
Open ground. Issue with one or more of the outlet receptacles. This may be an improper wiring issue or need a two-prong outlet receptacle installed instead of three-prong outlet receptacle. Consult electrician for evaluation and to make needed repairs.

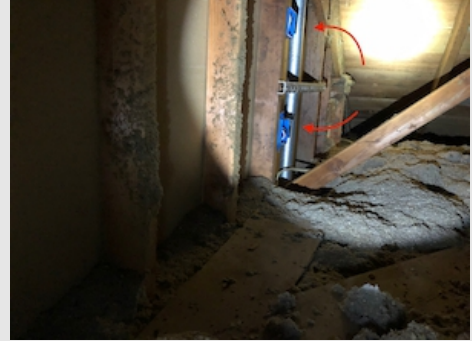
1) Missing receptacle cover. This is a safety concern. Ensure all outlet receptacles have a properly secured cover in place. 2) Missing junction box cover. All junction boxes need to be securely covered to protect the wire connections. Install covers where missing.

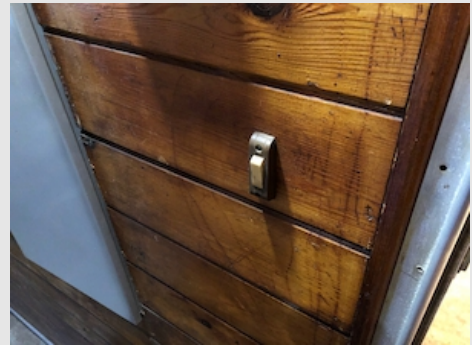
Doorbell is not operating. Consult electrician for evaluation and repair.

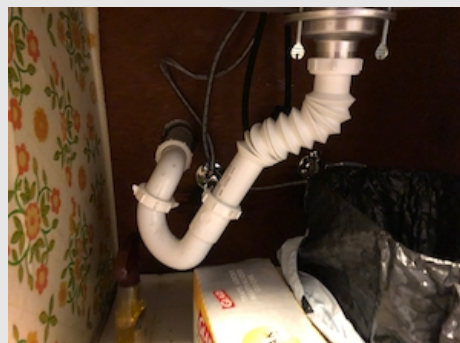
The drain piping is type and configuration that can lead to restricting build-up and leaks. Flex-type, corrugated piping is not recommended. Make needed repair and improvement.

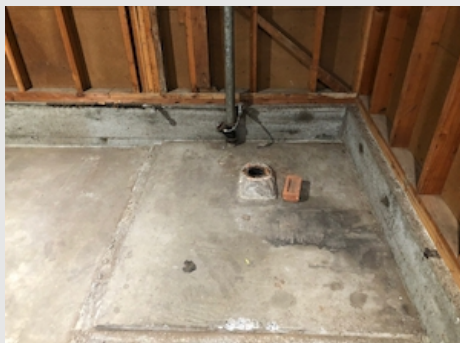
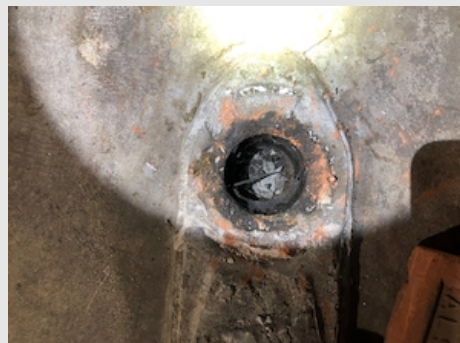
Cast iron
1) There is an open toilet waste hook up on the garage floor. Debris is visible in piping. Properly close this pipe.

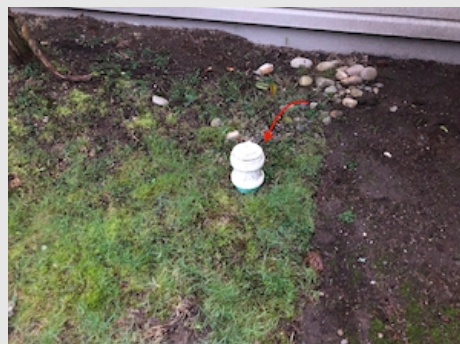
2) **Note:** There is a clean out that appears to be associated with the sewer line. This may be indicative of recent repairs made on the system.

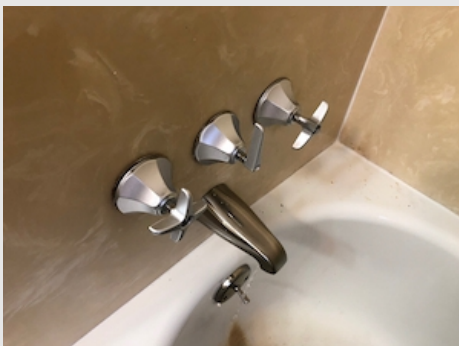
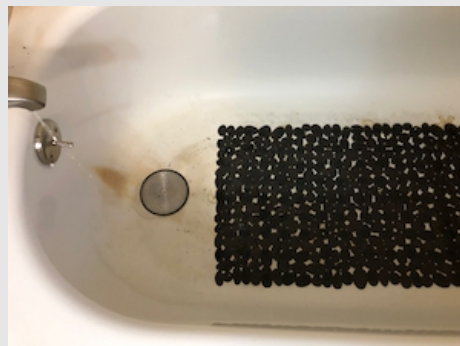
1) Faucet is not operating. Consult plumber for evaluation and repair. 2) Chip and/or staining present in finish. Consult contractor for further evaluation and repairs.

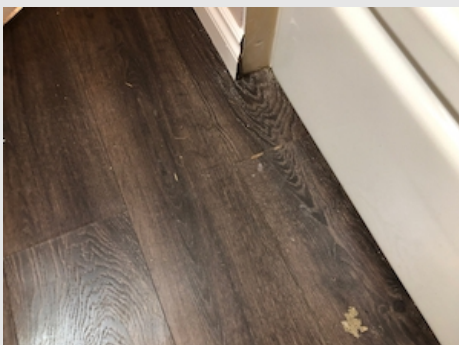
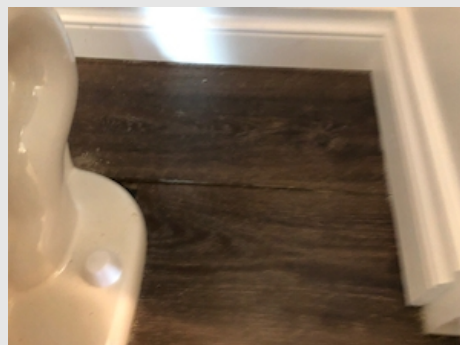
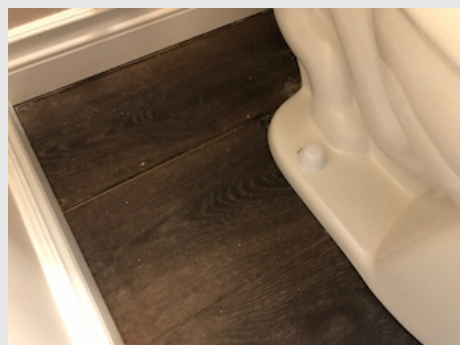
Separating and damaged flooring. This flooring is susceptible to moisture and appears to be poorly installed. Consult contractor for evaluation and repair.

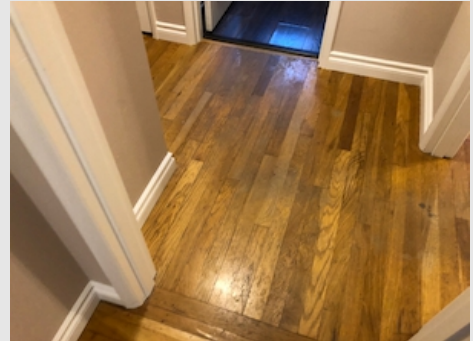
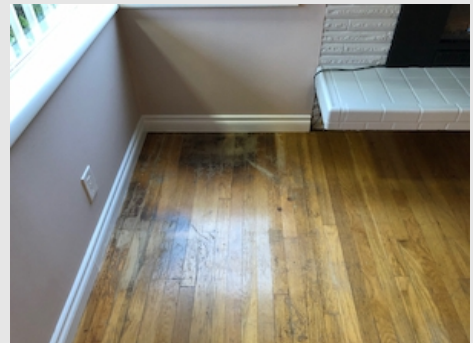
Areas of use and wear visible with hardware flooring including stains and discoloring. Consult contractor for evaluation and cleaning/repair.

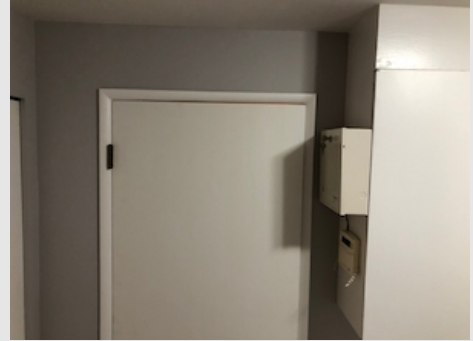
Door is not opening and closing properly - rubbing against the jam. Make necessary adjustments and/or repairs to the door.

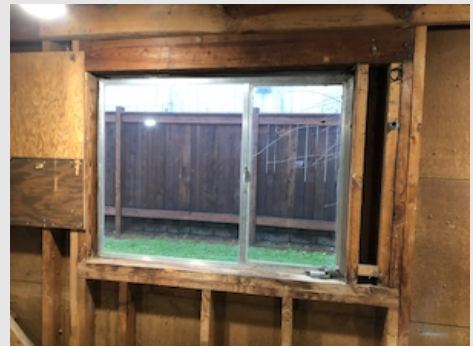
Issue with garage window that is not opening/closing properly and easily. Consult window contractor for evaluation and repair.

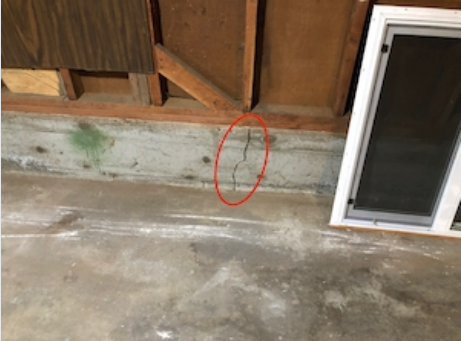
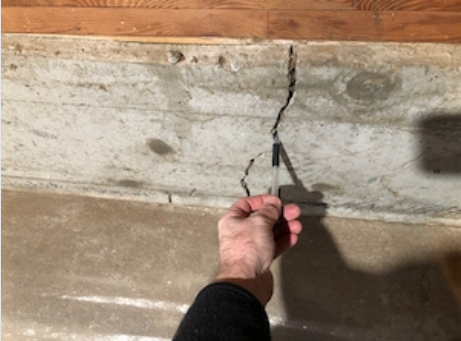
14.21	Foundation	Poured concrete. Minor crack visible with the foundation in the garage. These shrinkage or stress cracks are common as concrete cures, temperature fluctuates and with the passage of time. This does not appear to be active and there seems no evidence of adverse house movement. See WDO diagram for location. It is recommended that these be sealed with concrete filler/sealant to protect from possible moisture entry. Continue to monitor the repair for further separation.
	OVERVIEW PICTURE(S)

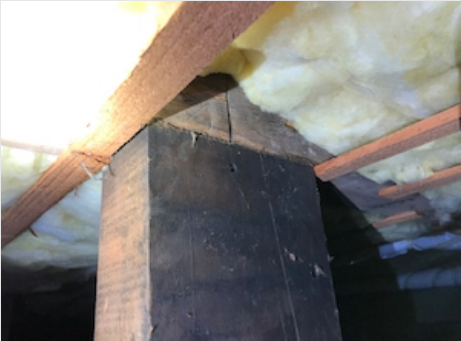
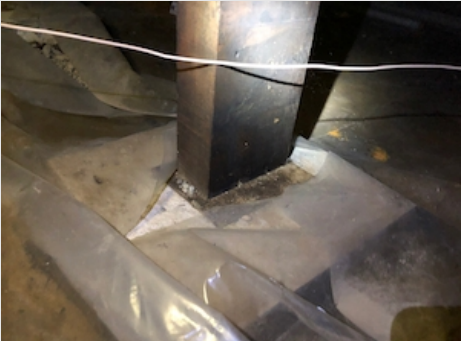
14.22	Posts and beams	Wood. Posts are not secured to the beams above and/or the footings below. This is a standard precaution for seismic movement (earthquakes). While standard practice in recent construction, this was generally not done in older houses. Consult contractor for evaluation and repair.
