# HOME INSPECTION REPORT

**November 1, 2020**

**17631 32nd Ave NE, Marysville**

**REFERENCE #: 1111\_Example**

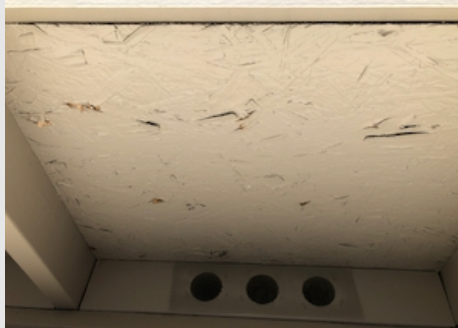
Peeling paint. Remove all loose paint and re-paint all bare wood to protect from moisture.

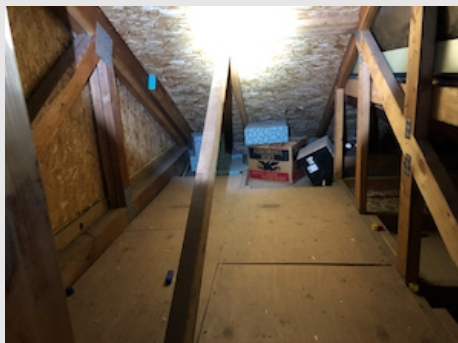
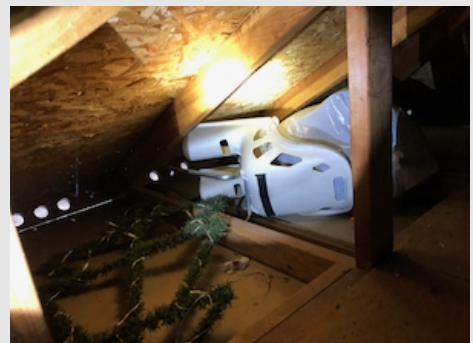
Storage and debris. Remove all items from attic area.

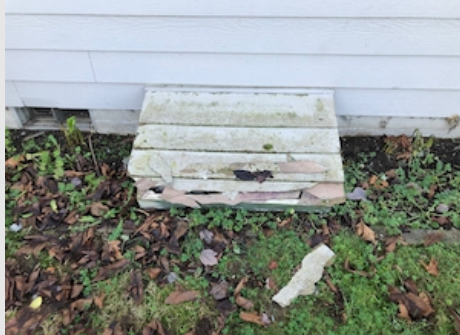
5.19 Other issues

Inadequate crawlspace access cover. Consult contractor for evaluation and repair. Improvements can include an additional screen insert or securely closing cover. Ensure crawlspace access cover protects from both moisture and pest entry in the crawlspace.

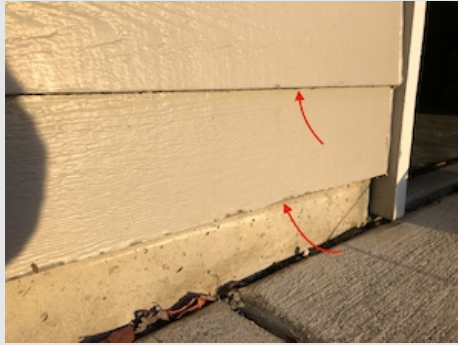
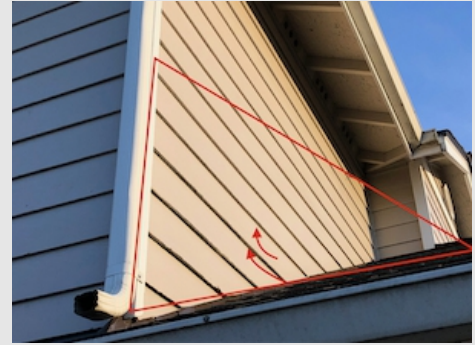
2) Hardiplank siding issue on south side. Installation concerns with the siding planks: 1) Nails have been used to secure the bottom edge and corners of the planks. This is not the proper installation and expansion of these boards will likely result in cracks and broken pieces of the siding. 2) Caulking has been used where joints are to be flashed and not caulked. Consult siding contractor for further evaluation, recommendations and repairs where needed.

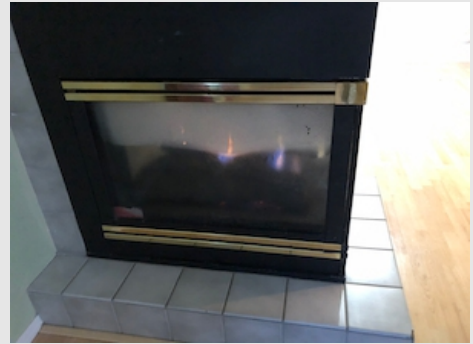
7.42 Condition Operating. Maintenance needed: It is recommended that the glass pane be cleaned.

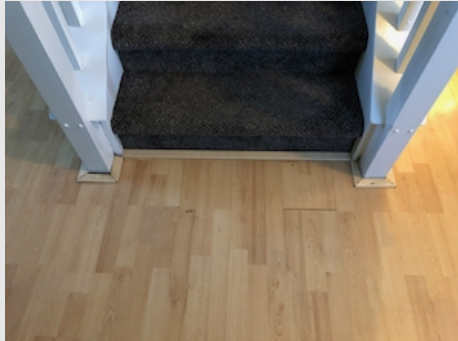
Excessive use and wear with laminate. Consult flooring contractor for evaluation and repair or replacement of worn flooring.

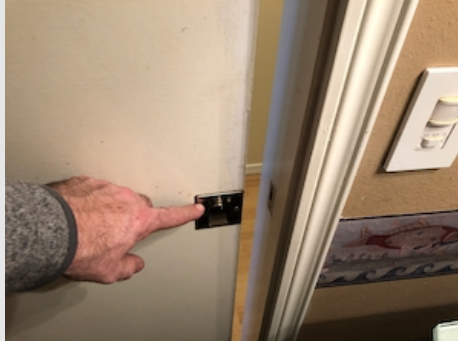
Issue with door latch that is not engaging properly. Make necessary adjustment or replace door handle and latching mechanism if these are faulty.

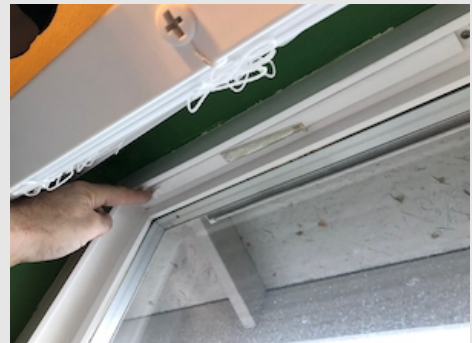
2) Vents are present in the window frame. These provide a valuable source of fresh air into the house in conjunction with the ventilation fan system. It is recommended that these vents remain open to ensure a regular air exchange within the house.

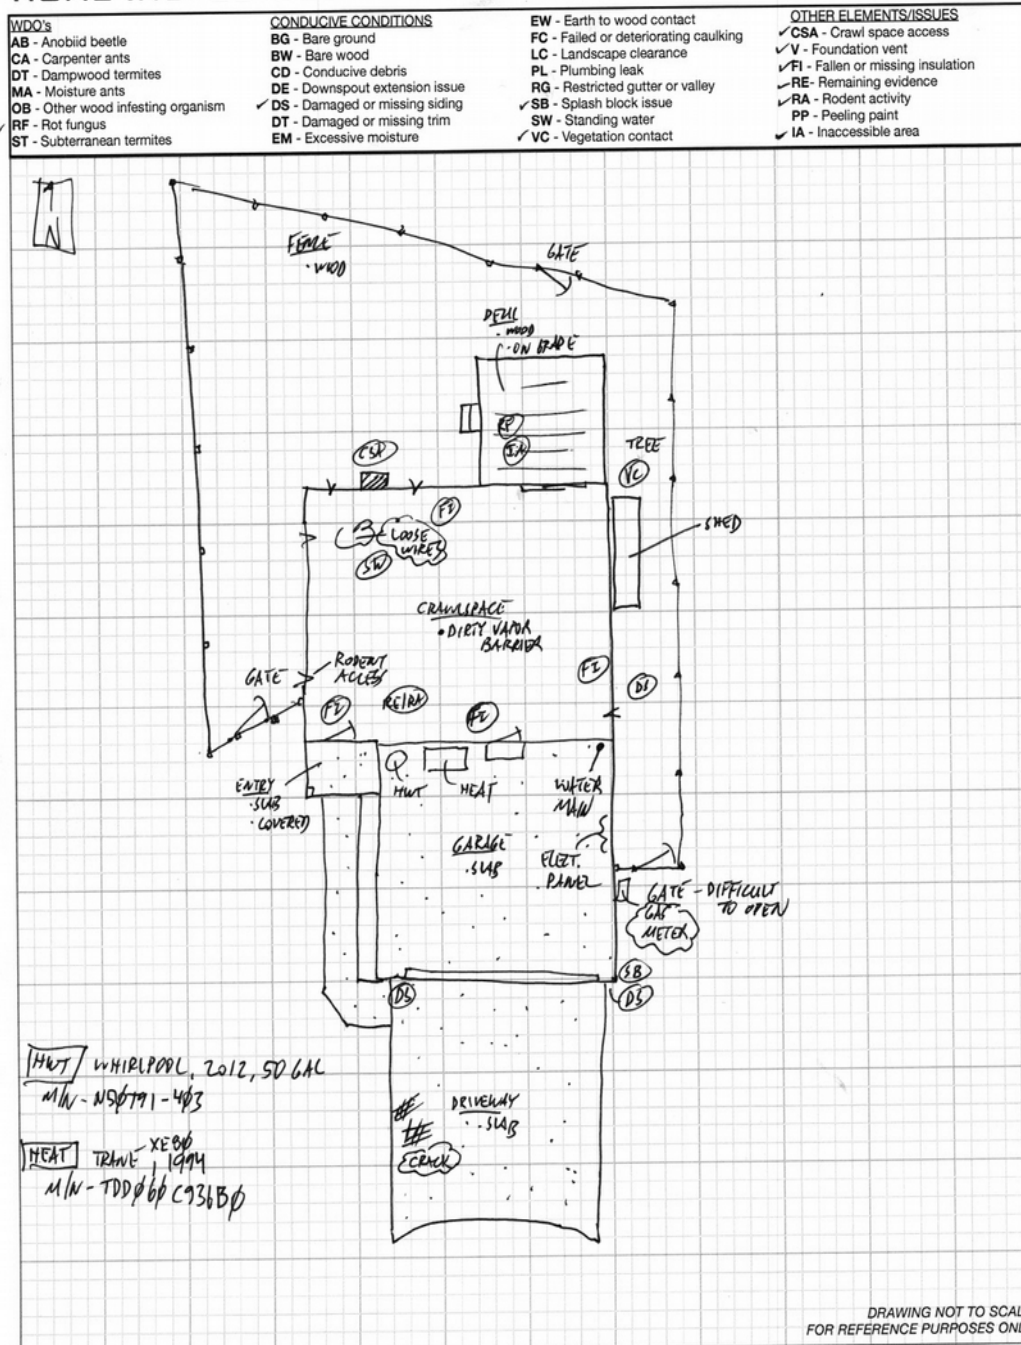
### WDO DIAGRAM WOOD-DESTROYING ORGANISMS

14.61	Issues noted	<i>Reference the WDO (wood-destroying organism) Diagram for specific location.</i>
14.62		<i>DS - damaged/missing siding. See remarks from exterior inspection.</i>

14.63		<i>SB - missing splash block. See remarks from roof inspection.</i>
14.64		<i>VC - vegetation contact. See remarks from grounds and/or roof inspection.</i>
