INSPECTION DATE

December 2, 2020

PROPERTY INSPECTED

555 Filbert Rd, Lynnwood, WA 98036

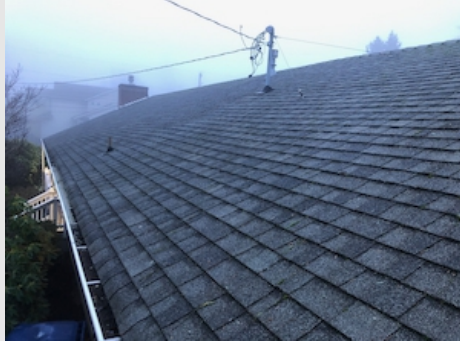
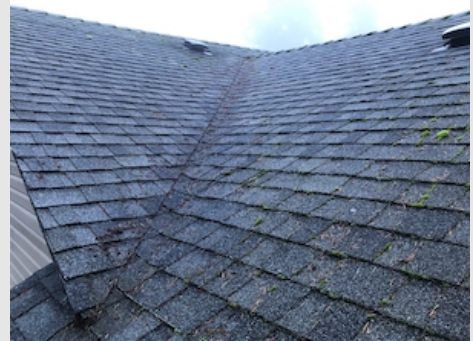
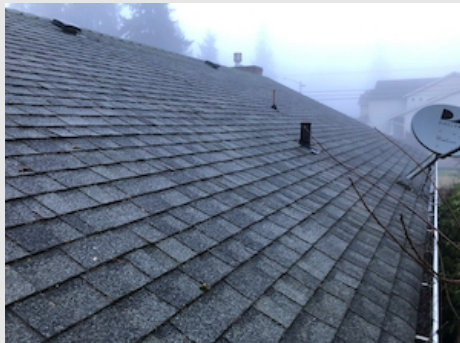
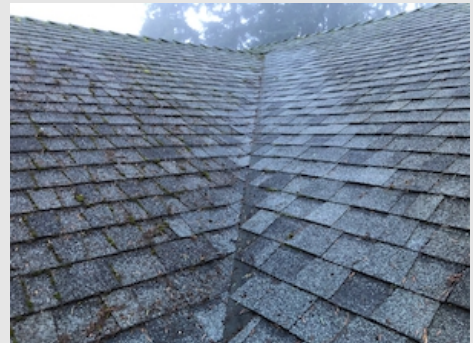
Composition laminated (architectural) shingle. This is usually considered a 25-30 year roofing material. Consult installer or manufacturer for further information on roofing warranty.

Standard maintenance needed for roofing that is consistent with its age or installation. Evidence of past repairs. Continue to perform repairs as needed.

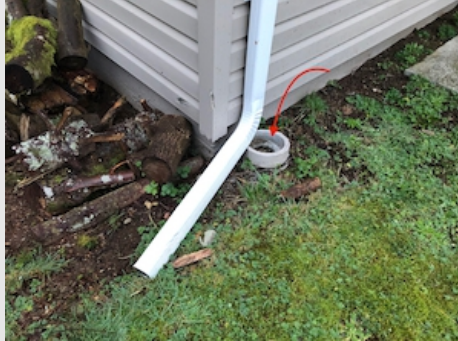
1) Drains present. Issue: Debris visible in drains. Obstructed drains can result in water pooling near the house. Make needed repairs to clear drains and ensure proper water drainage. 2) Missing splash block trays. Install trays to ensure water moves away from the foundation of the house.

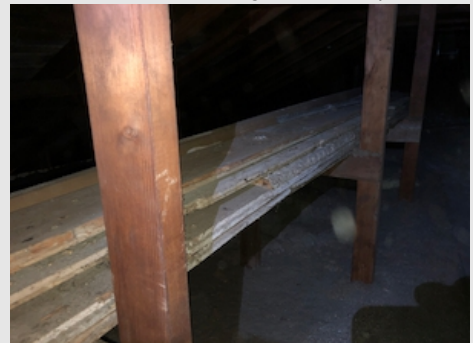
3.13 Storage

Remove all storage and items from attic area. This area is not intended for storage and items present reduce the airflow for attic ventilation.

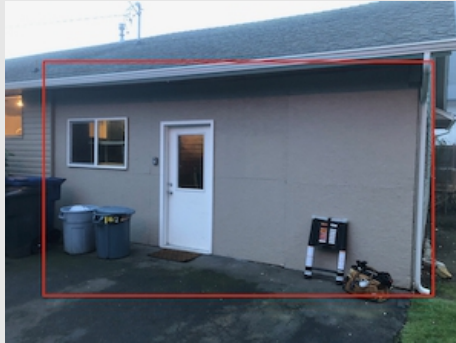
6.32 Condition

Carport conversion is inadequate. OSB is not a proper material for exterior application and the window is not properly flashed. Consult contractor for evaluation and repair.

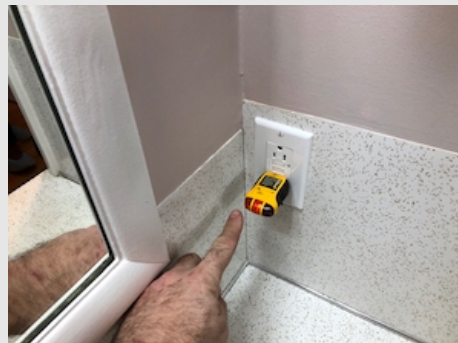
Not operating properly. The testing device or the test switches on the receptacle did not trip as designed. Consult electrician for evaluation and repair of GFCI outlet protection.

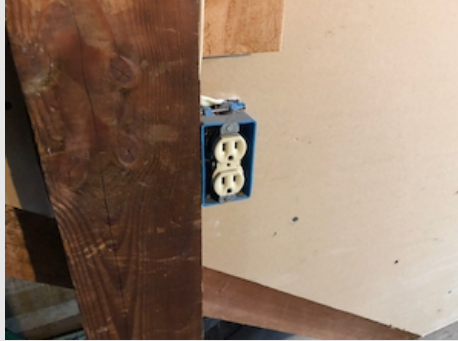
8.38 Other issues:

1) Missing receptacle cover. This is a safety concern. Ensure all outlet receptacles have a properly secured cover in place. 2) Missing junction box cover. All junction boxes need to be securely covered to protect the wire connections. Install covers where missing.

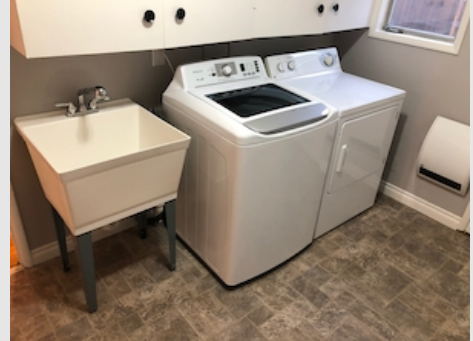
10.11	Issues noted	No issues observed
10.12	Ventilation fan	Not present. Ventilation fans are important in expelling moisture and reducing the conditions for organic growth in the house including the attic. It is recommended that a ventilation fan be installed if possible. Consult contractor for recommendations.
10.13	Utility sink	No issues observed

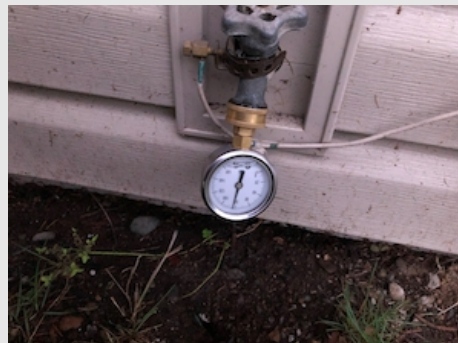
Galvanized steel. This material deteriorates as it ages and can restrict water flow or leak. Consult plumber for further evaluation.
Satisfactory: 70-80psi
No issues observed
No issues observed
Leak noted at faucet handle when in use. Consult plumber for evaluation and repair to reduce water loss when faucet is in use. NOTE: Insulate exterior faucets to protect from freezing temperatures.

** Tested at exterior faucet.*

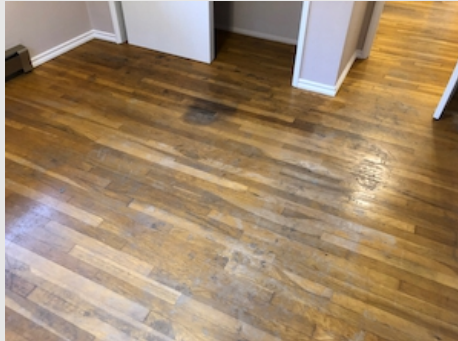
Areas of use and wear visible with hardware flooring including stains and discoloring. Consult contractor for evaluation and cleaning/repair.
